TWO-STAGE POTASSIUM TEST TURBINE

Volume IV

Materials Support of Performance
and Endurance Tests

Prepared under Contract No. NAS 5-1143 by
GENERAL ELECTRIC
Cincinnati, Ohio

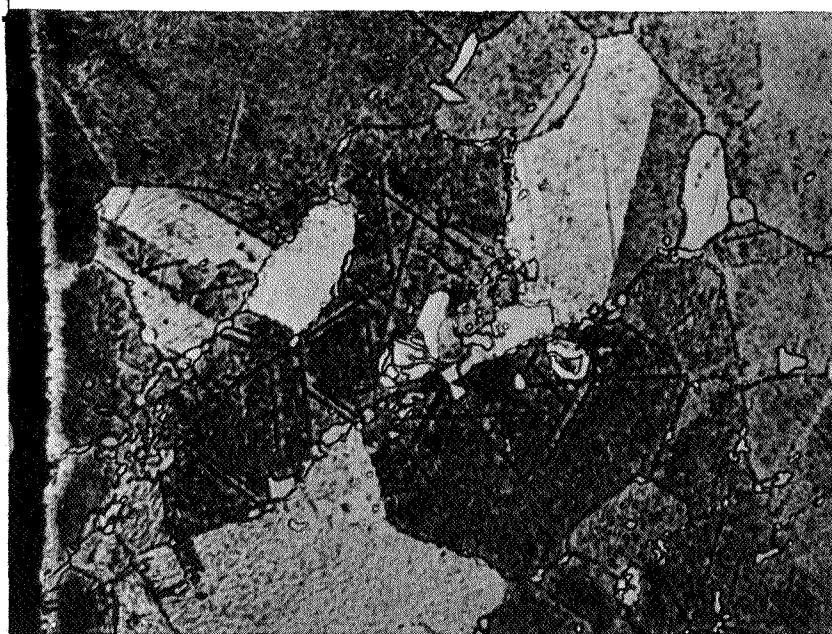
Figure 6. First Stage U-700 Blade Dovetail After 2000-Hour Endurance Test Showing Concentration of Accicular Structure Presumed to be Sigma Phase. (B322411)

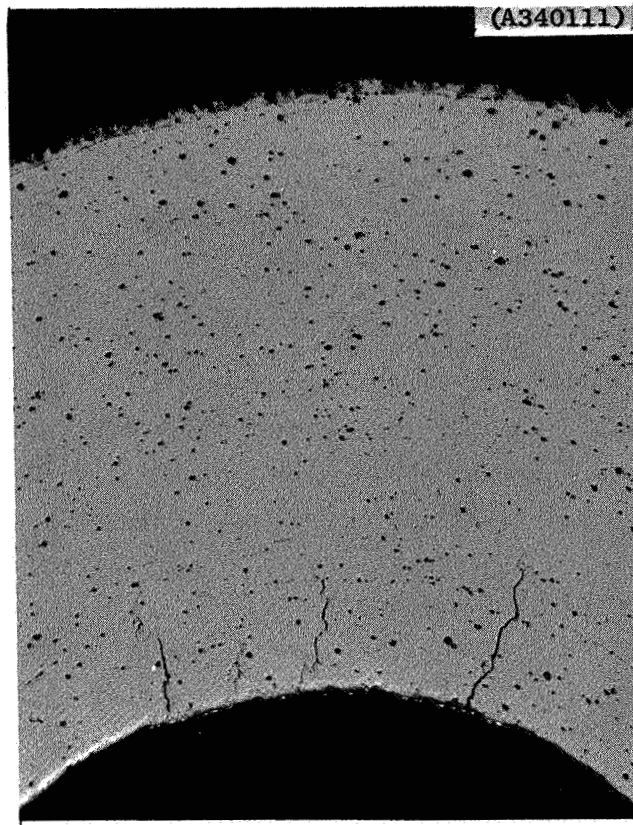
3. Turbine bucket locking strips were increased in thickness for the performance test. These strips failed by strain age cracking in the sharply bent forward radius. This problem was eliminated by using a more generous bend radius and by re-solution treating the fabricated locking strips before installing them in the turbine wheel assembly; the locking strips were aged in place during turbine operation.

Figure 8. Forward Radius of Rene' 41 Turbine Blade Locking Strip Showing Strain Age Cracking. (A340111)

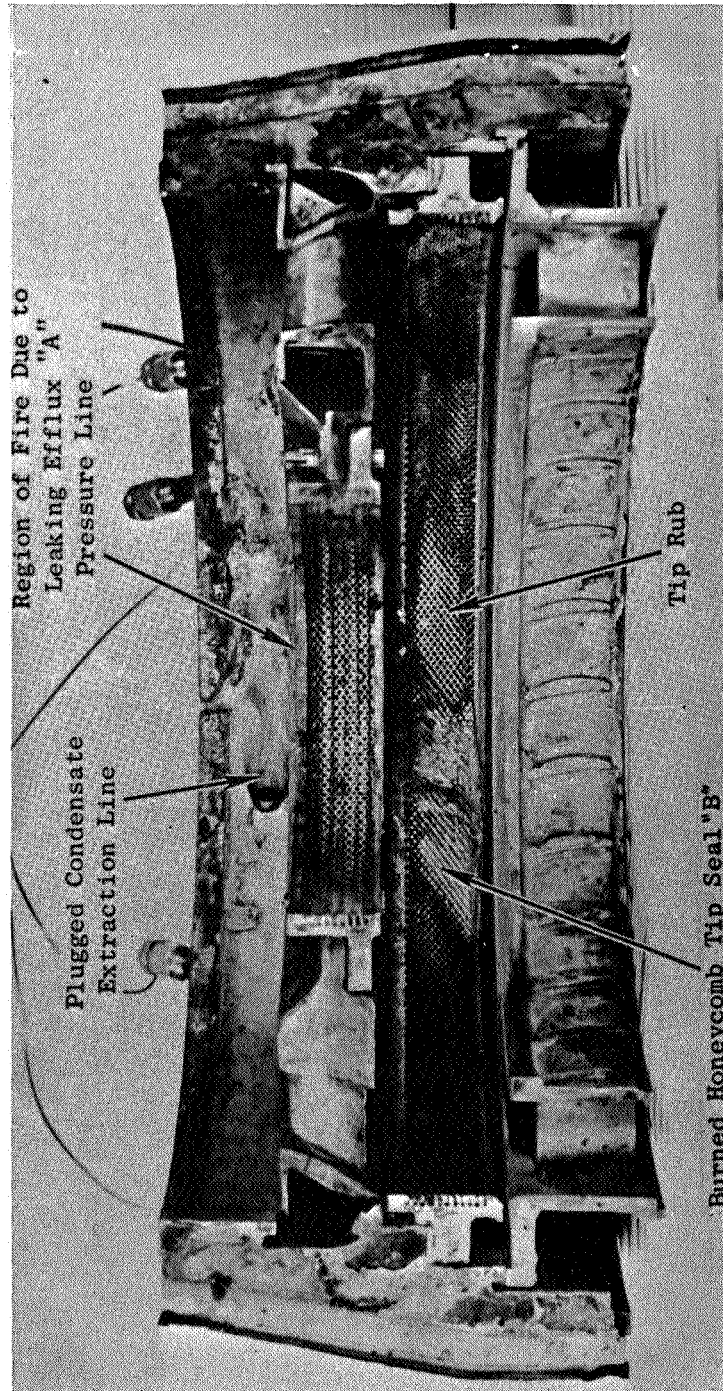
Figure 36. Fire Damage in Second Stage Tip Seal During 35-Hour Turbine
Checkout. (C64120413) Mag: 1/2X

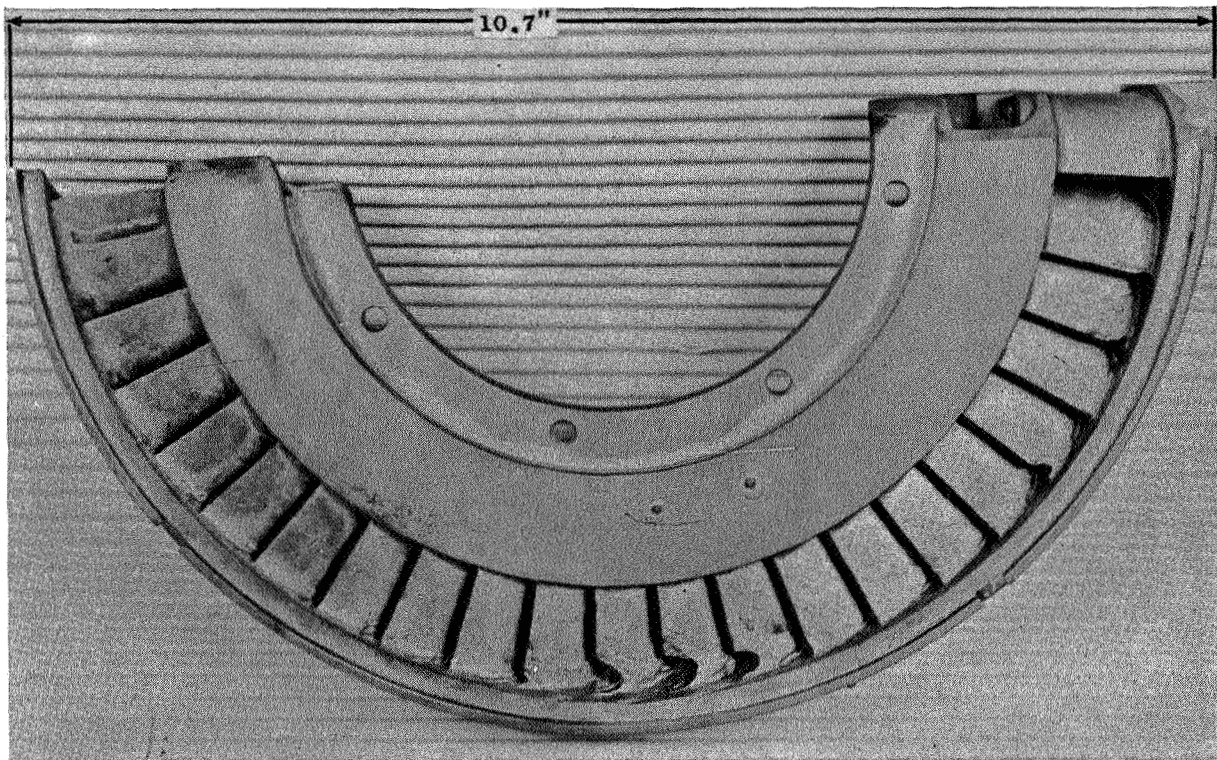
Figure 38. Fire Damage to Second Stage Nozzle Diaphragm Vanes During 35-Hour Turbine Checkout. (C64121803)

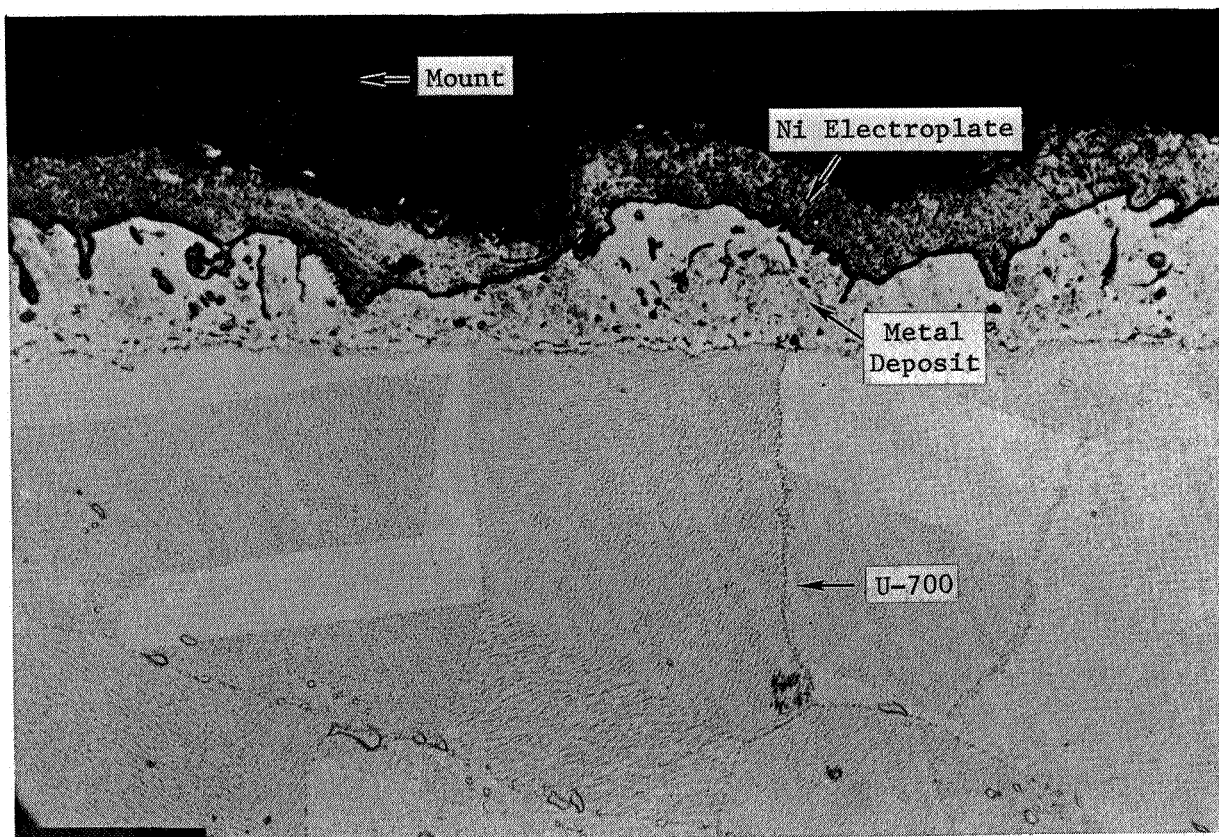
Figure 42. Metal Deposit on First Stage Blade Concave Surface After 35 Hour Turbine Checkout. (L171)

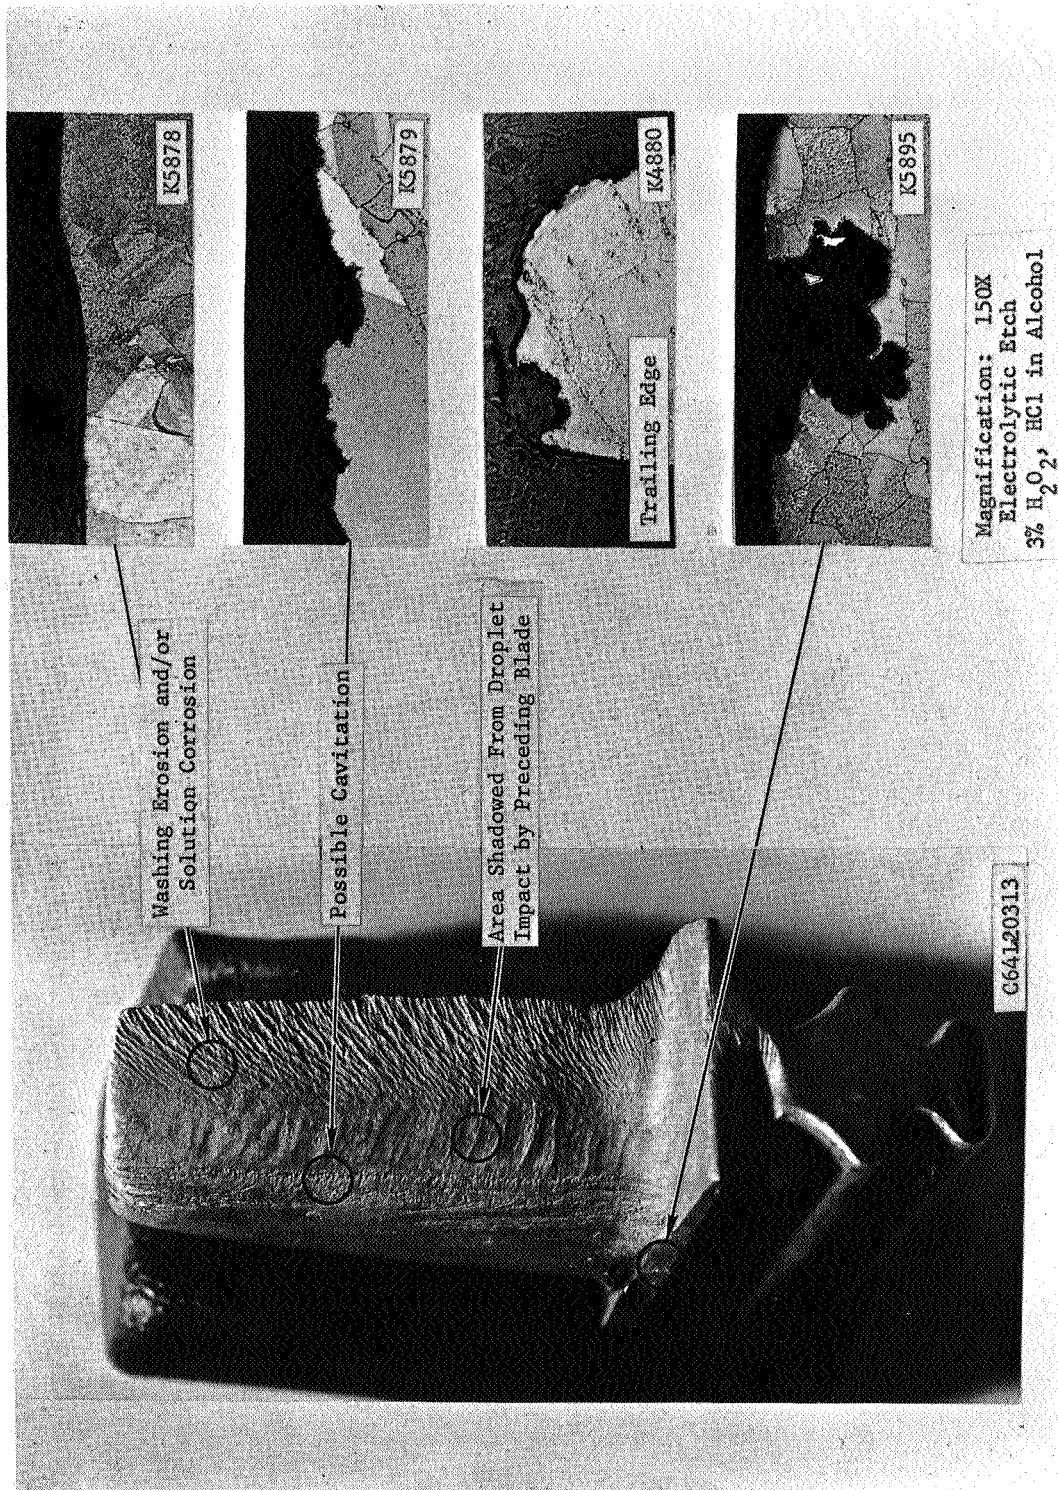
Figure 44. Photomicrographs Showing Nature of Metal Removal from Surface of First Stage Turbine Blade After 35-Hour Turbine Checkout.

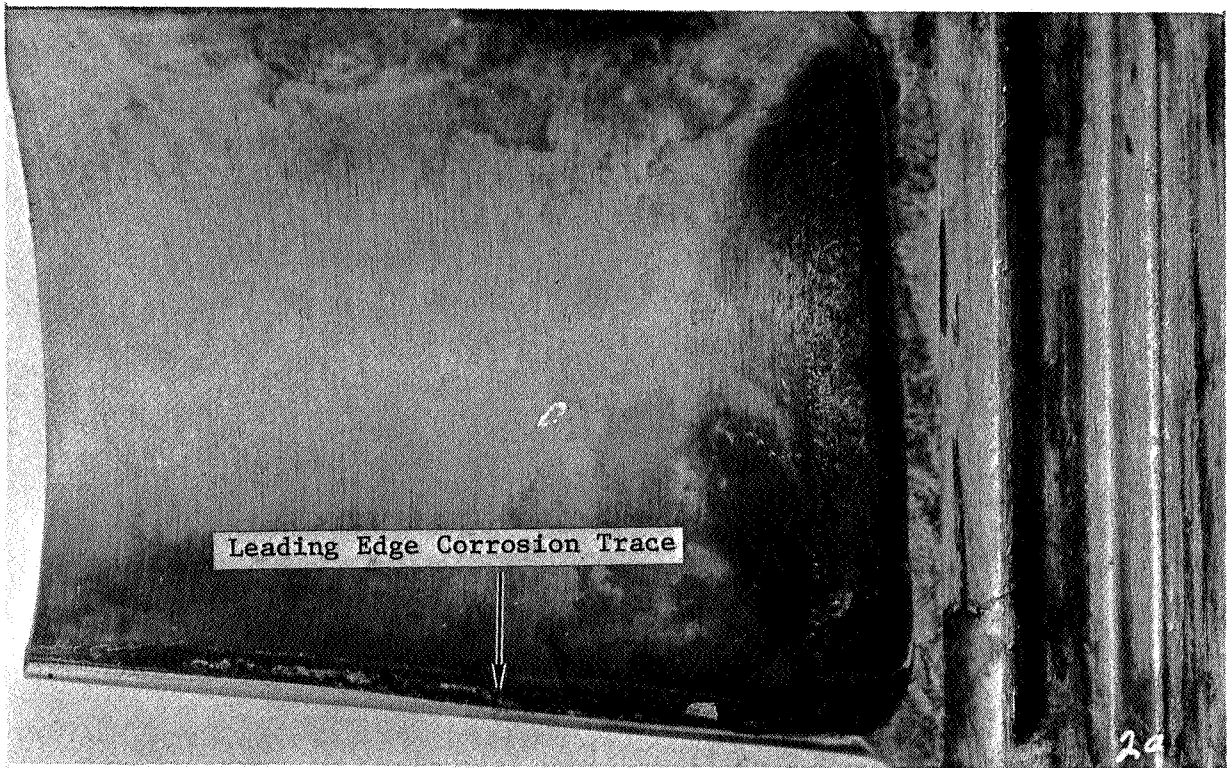
Figure 59. Concave Side of TZM Second Stage Turbine Blade After 2000-Hour Endurance Test. Note Leading Edge Corrosion. (C66011348)

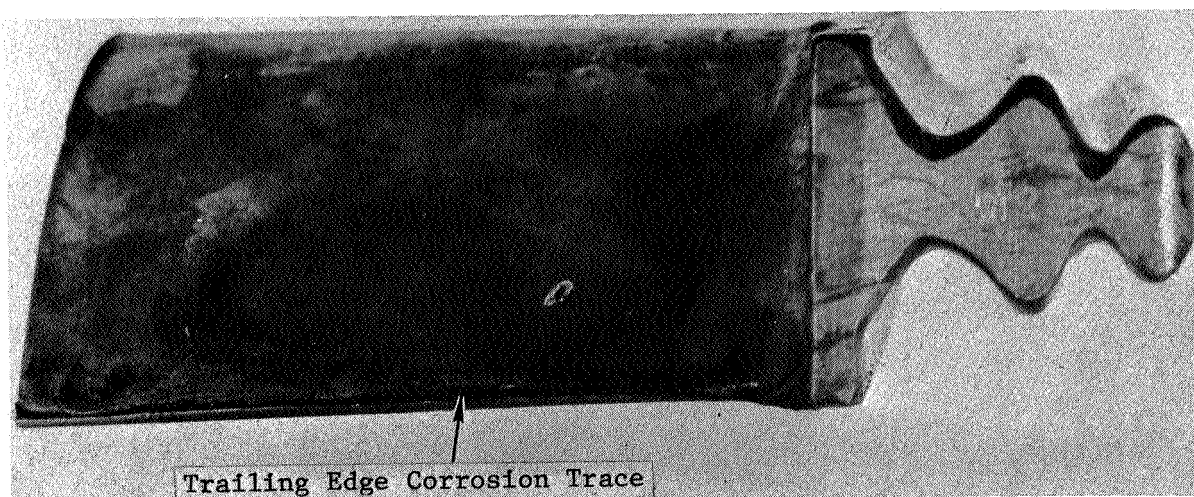
Figure 60. Trailing Edge of TZM Second Stage Turbine Blade After 2000-Hour Endurance Test. Note Corrosion at Trailing Edge.
(C66011328) Mag: 5X

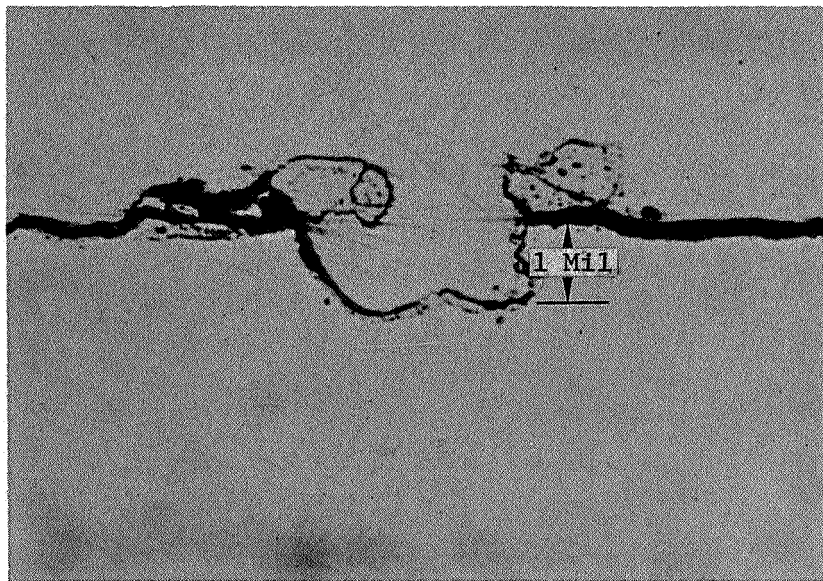
Figure 65. Convex Surface of TZM Second Stage Blade at Major Corrosion Area After 2000 Hour Test. (B320312)

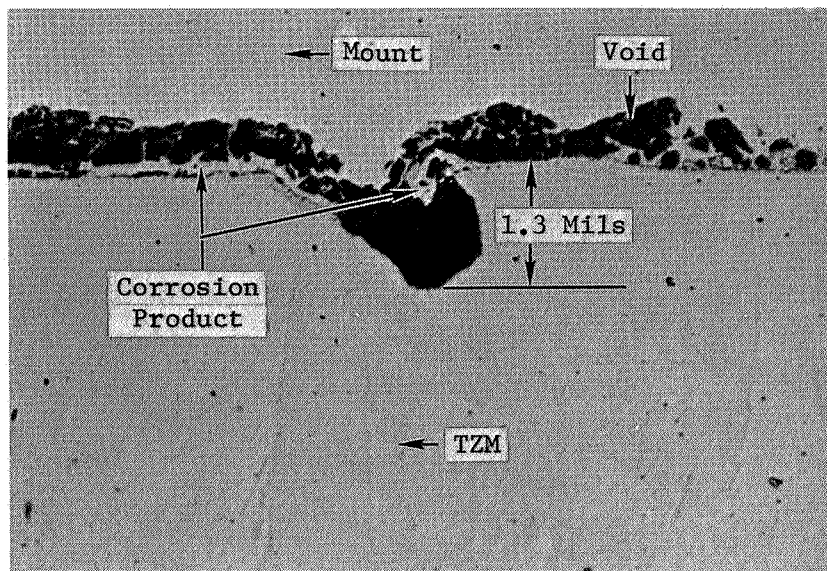
Figure 67. Tip of TZM Second Stage Turbine Blade at Major Corrosion Trace After 2000 Hour Test. (B320112)

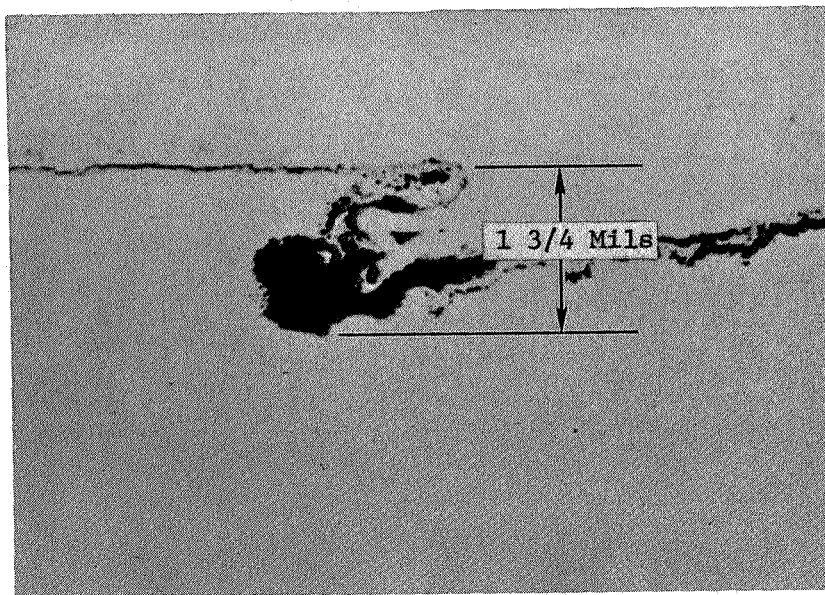
Figure 68. Tip of TZM Second Stage Turbine Blade at Major Corrosion Trace After 2000 Hour Test. (B320211)

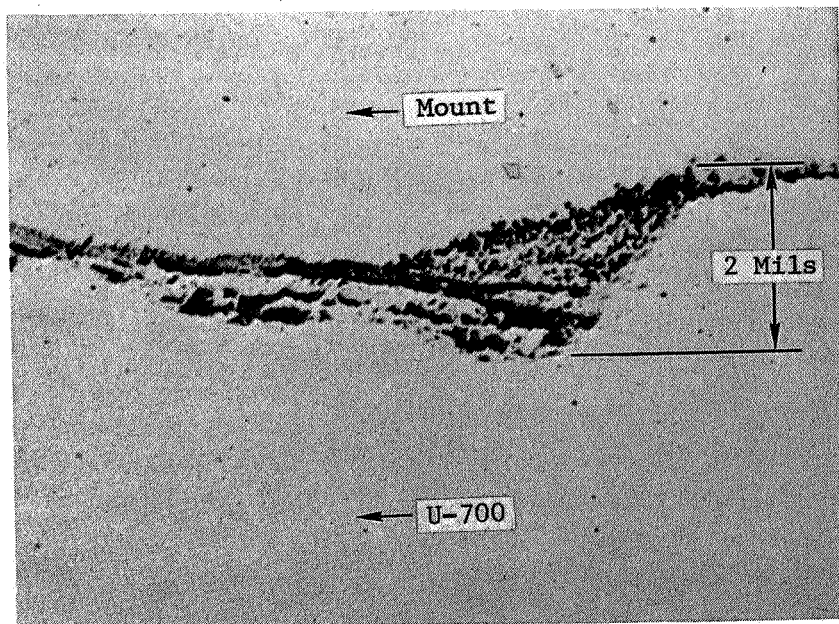
Figure 71. Corrosion Cavity at Concave Leading Edge of a First Stage U-700 Blade After 2000 Hour Endurance Test. (B321511)

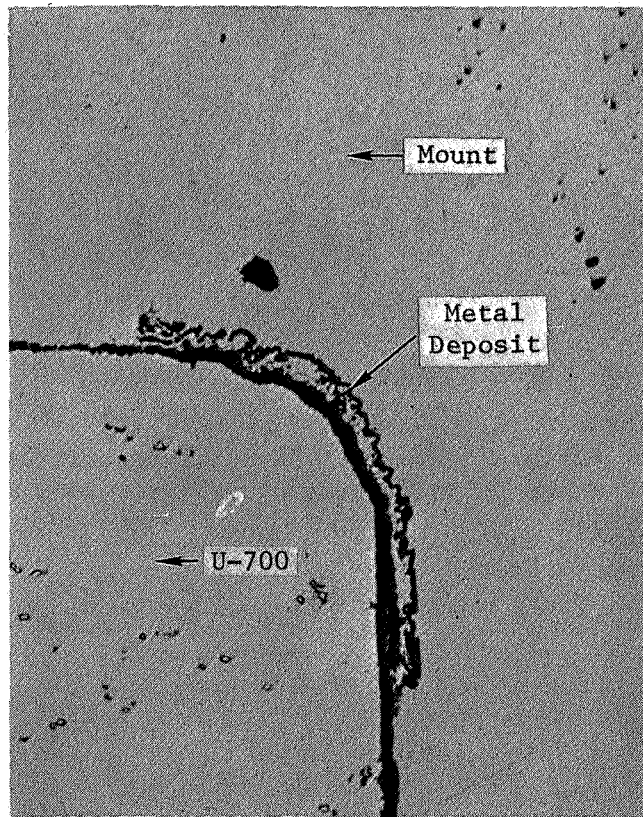
Figure 74. Surface Corrosion and Metal Deposit at Concave Tip of a U-700 First Stage Turbine Blade After 2000 Hour Endurance Test. (B322011)

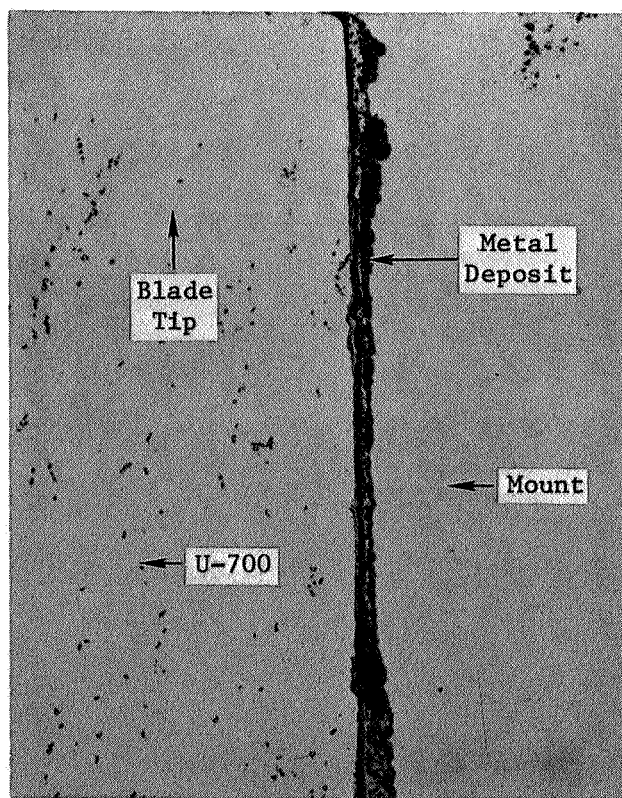
Figure 75. Light Surface Corrosion and Metal Deposit on Convex Tip of a First Stage U-700 Turbine Blade After 2000 Hour Test. (B322012)

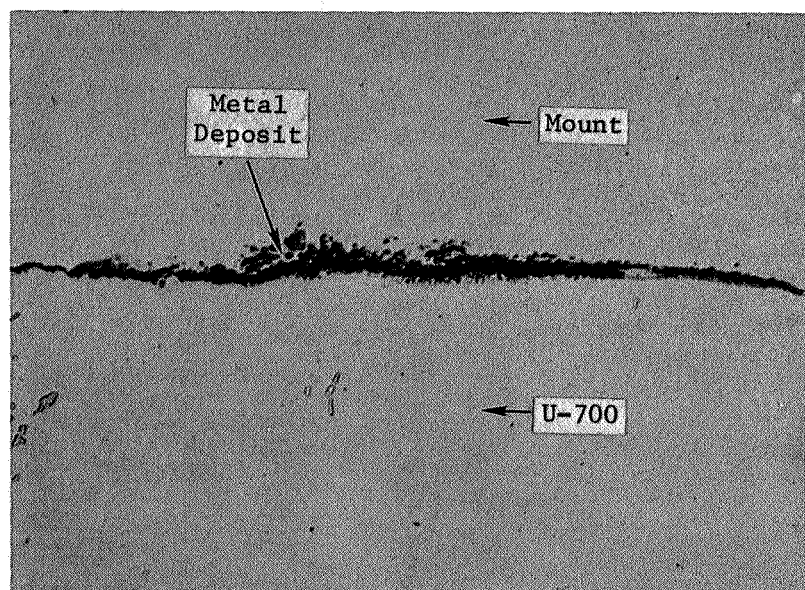
Figure 76. Corrosion and Metal Deposit on Convex Trailing Edge of a First Stage U-700 Turbine Blade After 2000 Hour Test. (B322114)

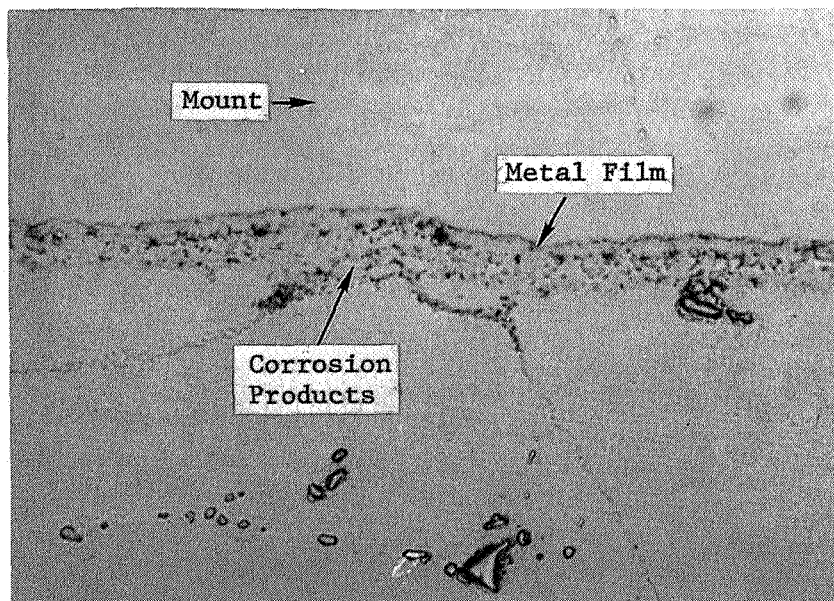
Figure 78. Metal Film Deposit Overlaying Corrosion Products on the Concave Tip Surface of a First Stage U-700 Turbine Blade After 2000 Hour Test (B320712)

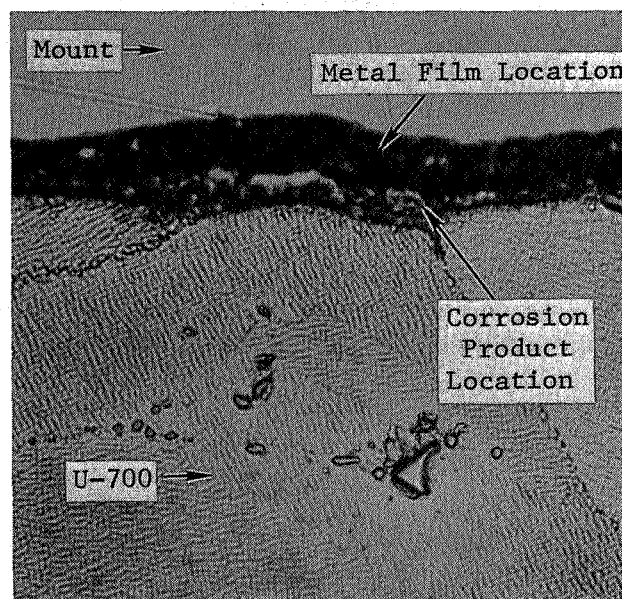
Figure 79. Metal Film Deposit Overlaying Corrosion Products on the Concave Tip Surface of a First Stage U-700 Turbine Blade After 2000 Hour Test. (B320713) Area Shown is that of Figure 78.

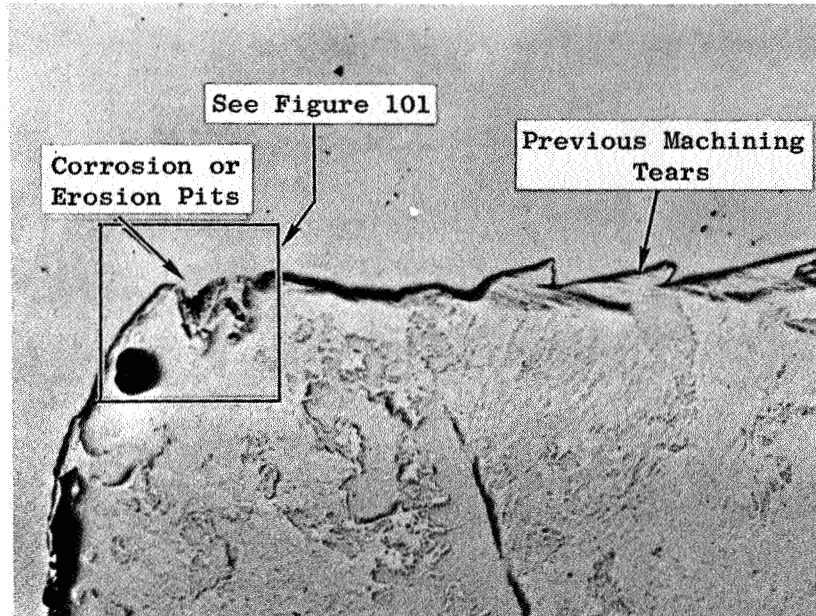
Figure 100. Corrosion Pits in TZC Erosion Insert Specimen D-2.
Etchant: Unetched Mag: 100X

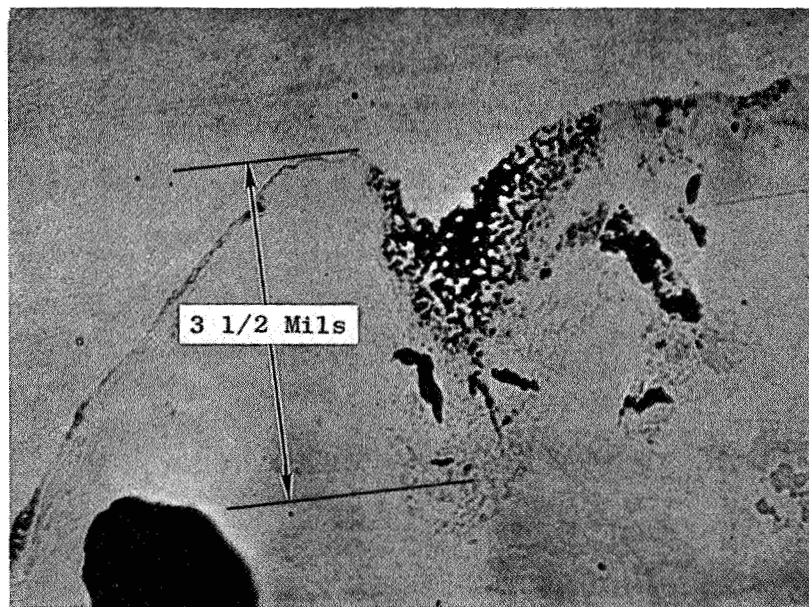
Figure 101. Corrosion Pit in TZC Erosion Insert Specimen
Etchant: Unetched Mag:

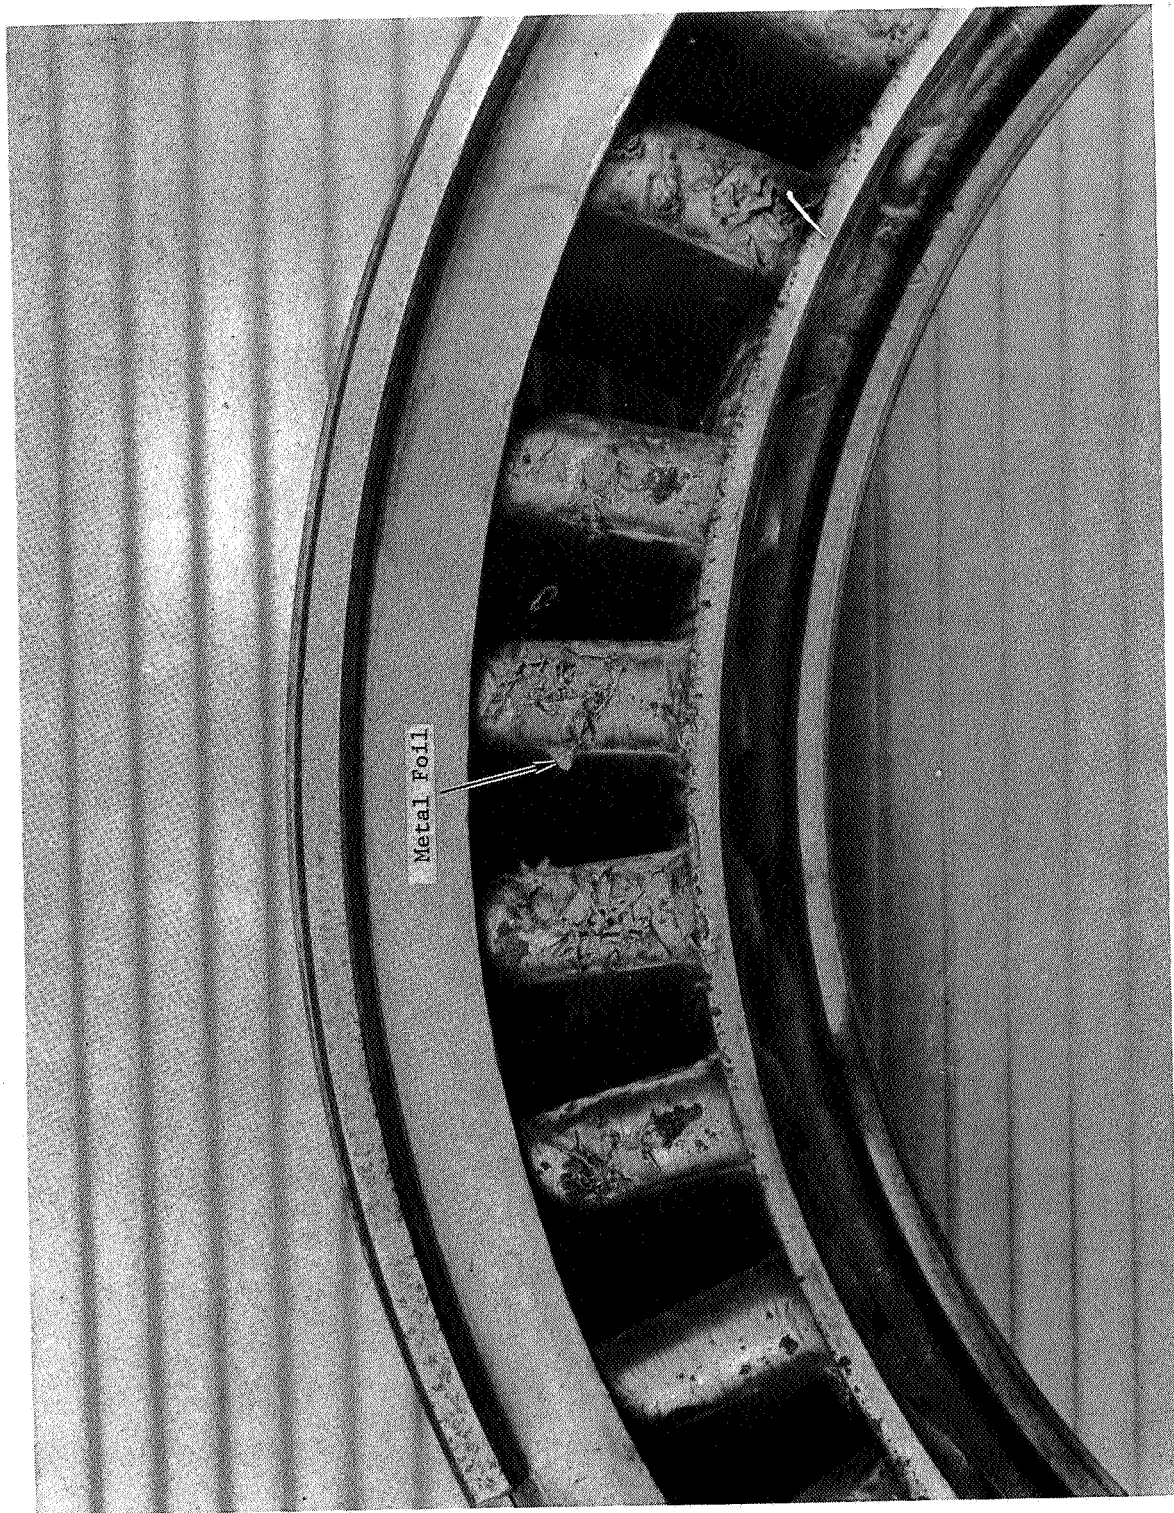
Figure 104. Metal Foil Deposits Impacted on the First Stage Turbine Nozzle
Diaphragm After Performance Testing. (C65061516)

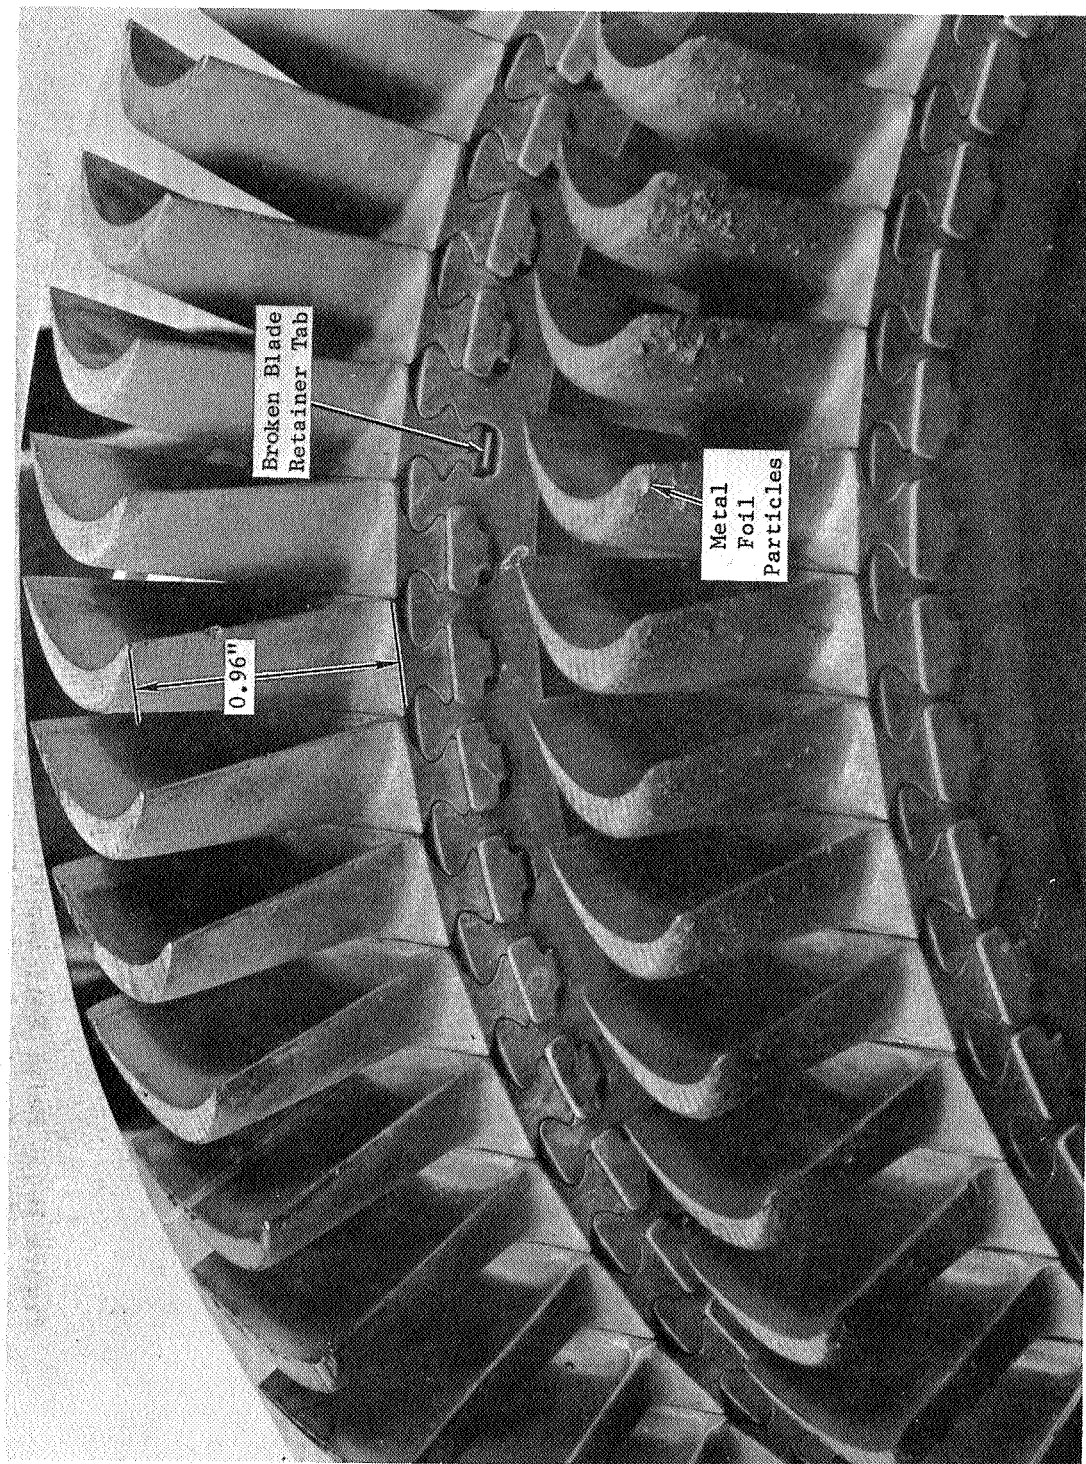
Figure 105. Close-up of Rotor Blades Showing Metal Foil Particles Impacted on First and Second Stage Blades. (C65060726)

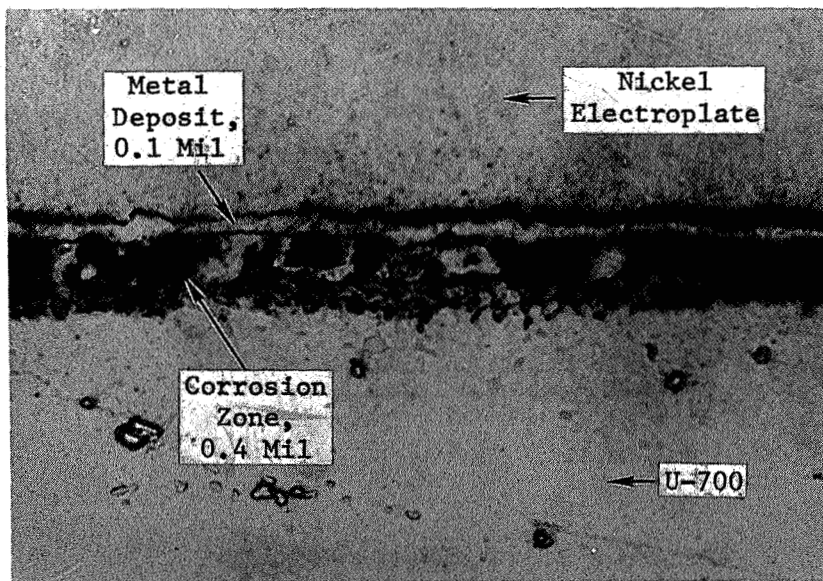
Figure 112. Concave Surface of First Stage U-700 Endurance Test Blade Near Leading Edge Showing Metallic Film Deposit and Underlying Corrosion. (B322112)

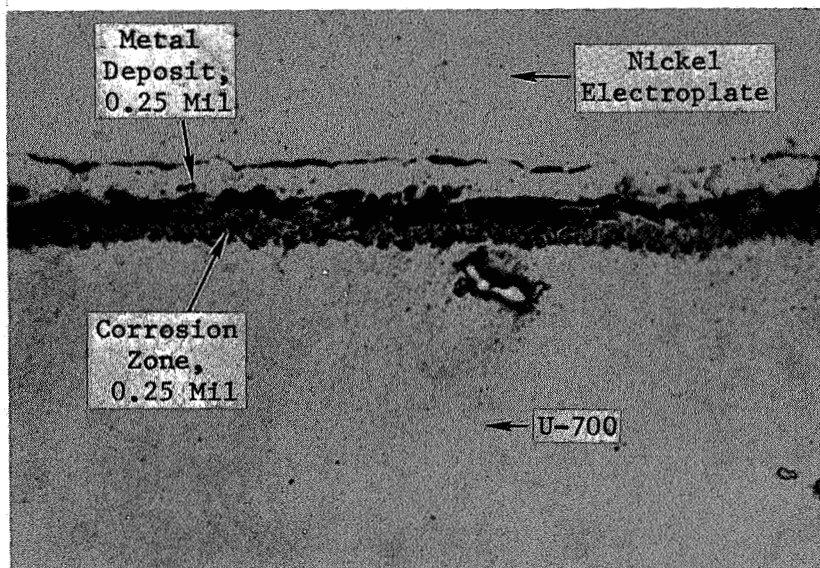
Figure 113. Convex Surface of First Stage U-700 Endurance Test Blade Near Leading Edge Showing Metallic Film Deposit and Underlying Corrosion. (B322113)
